Manhole Inspection Summary

Manhole # S17AA_005MH

Insp Date: **10/31/07 10:16 AM**

Location Address: **829 BENTALOU ST**

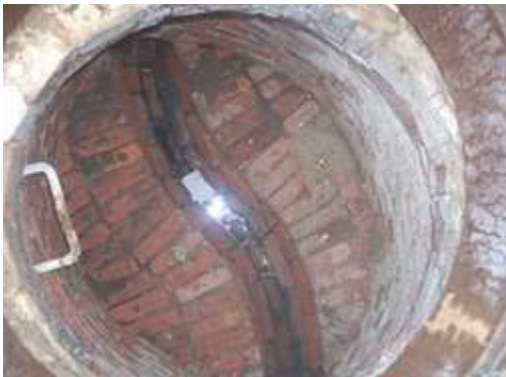
Defect 4

Count: **1** Missing: **0** ☒ **Corroded**

CORRODED STEPS

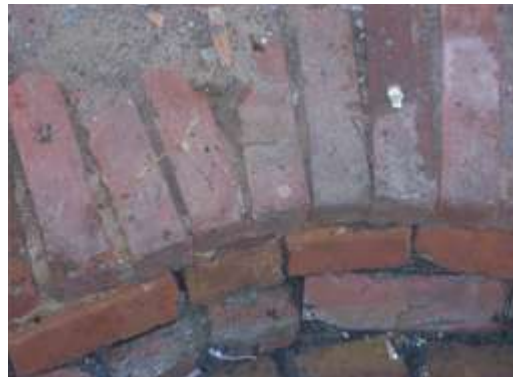
Defect 3

Condition: ☐ Sound ☐ Cracked ☐ Root Intrusion ☐ Deteriorated ☒ **Leaks** ☐ Debris

LEAKS IN THE CHANNEL

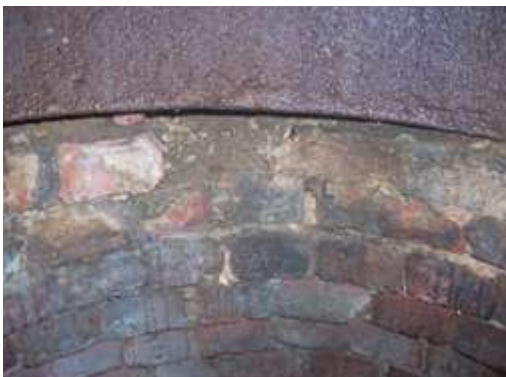
Defect 2

Condition: ☐ Sound ☐ Cracked ☐ Root Intrusion ☐ Loose Brick ☒ **Deteriorated**

DETERIORATED CORBEL

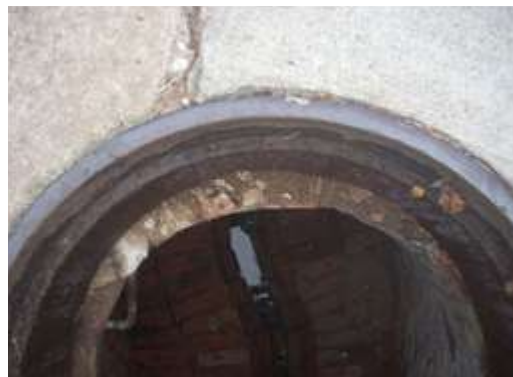
Defect 1

Offset: **2** (in.)

FRAME OFFSET

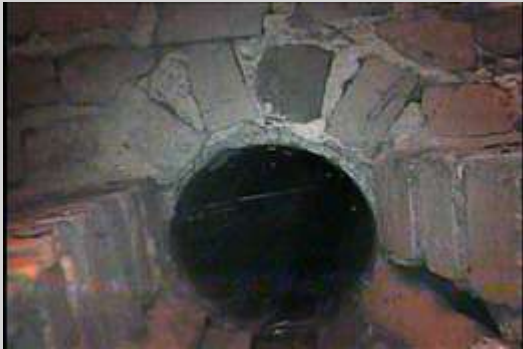
12 O'Clock Outflow

8 in. Circular Gravity Sewer
Pipe Out @ 12 O'Clock

Pipe Height: **8.4** (in.) Rod and Bar (Angled)
Pipe Material: **Clay** ☐ Pipe Lined
Invert Depth: **5.53** (ft.) Flow Characteristics: **Slow**
Deposits: ☒ None ☐ Mud ☐ Sludge ☐ Debris ☐ Grease
Silt Depth: (in.) Deposits Extent:
Infiltration: **None** Pipe Seal Cond: **Sound**

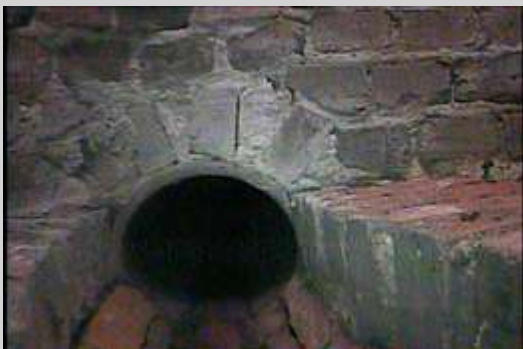
6 O'Clock Inflow

8 in. Circular Gravity Sewer
Pipe In @ 6 O'Clock

Pipe Height: **7.2** (in.) Rod and Bar (Angled)
Pipe Material: **Clay** ☐ Pipe Lined
Invert Depth: **5.48** (ft.) Flow Characteristics: **Slow**
Deposits: ☒ None ☐ Mud ☐ Sludge ☐ Debris ☐ Grease
Silt Depth: (in.) Deposits Extent:
Infiltration: **None** Pipe Seal Cond: **Sound**
